**DRAFT REPORT
OF
SPRINGFIELD LAKE NO. 1
OUTLET STRUCTURE & CHANNEL STUDY**

*Task A – Conceptual Plan
Interim Report*

Springfield Township, Summit County

DLZ Job No. 2322-6015.00

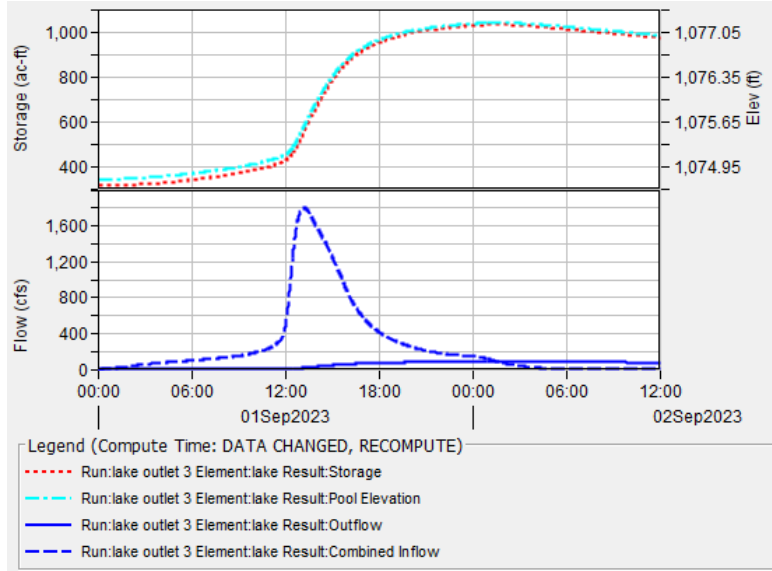
The resulting inflow hydrograph to the lake and outflow hydrograph exiting the lake during the 100-year flood condition from the HEC-HMS model results are shown in **Figure 5**. In the 100-year storm, HEC-HMS predicted a peak outflow discharge of 84 cfs with a maximum pool level of 1077.2 ft.

Figure 5: Inflow Hydrograph to the Lake and Routed Outflow Hydrograph in the 100-year Condition

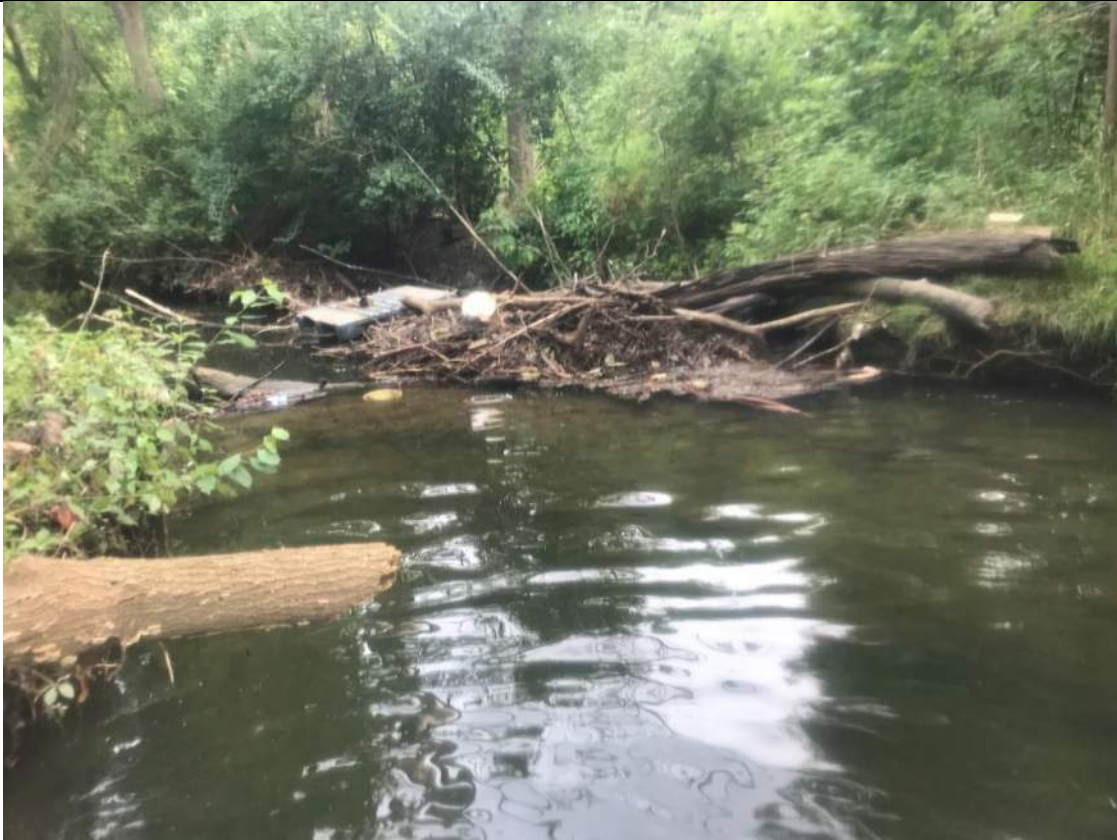
Photograph No. 59
STA 44+00 Downstream photo of buildup in creek

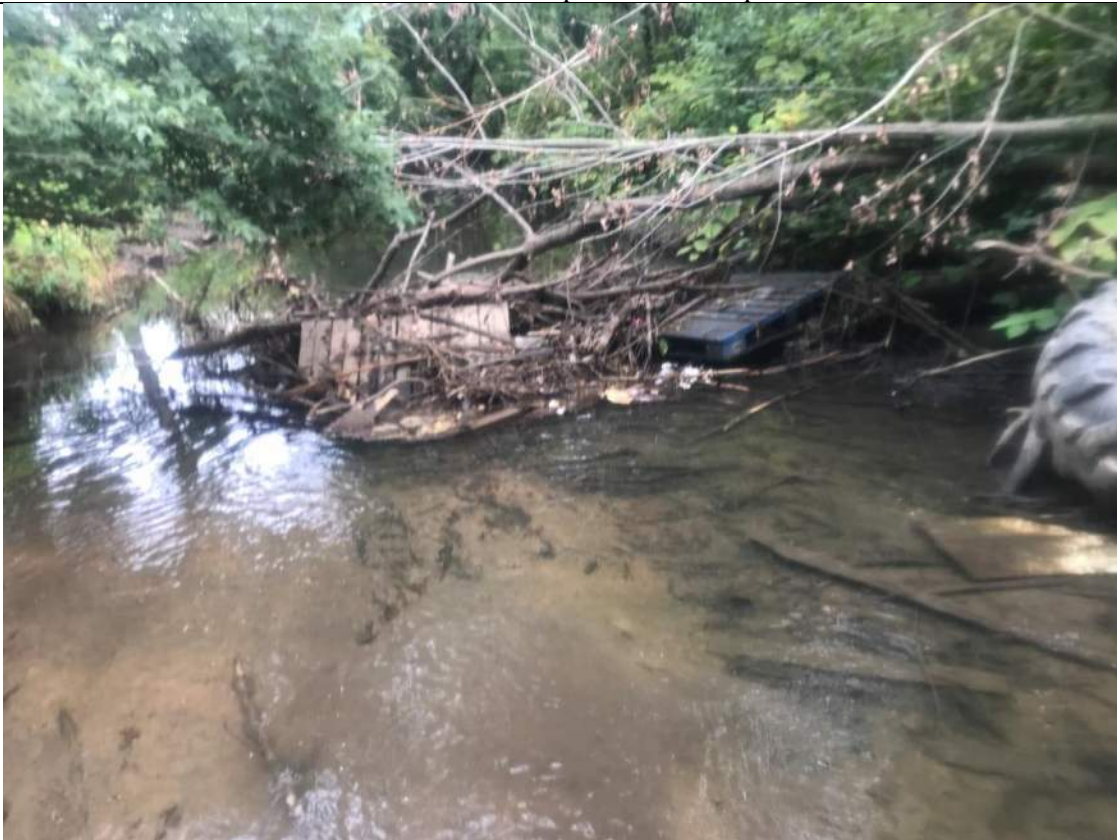
Photograph No. 60
41°2'24" N 81°26'6" W Downstream photo of buildup in creek

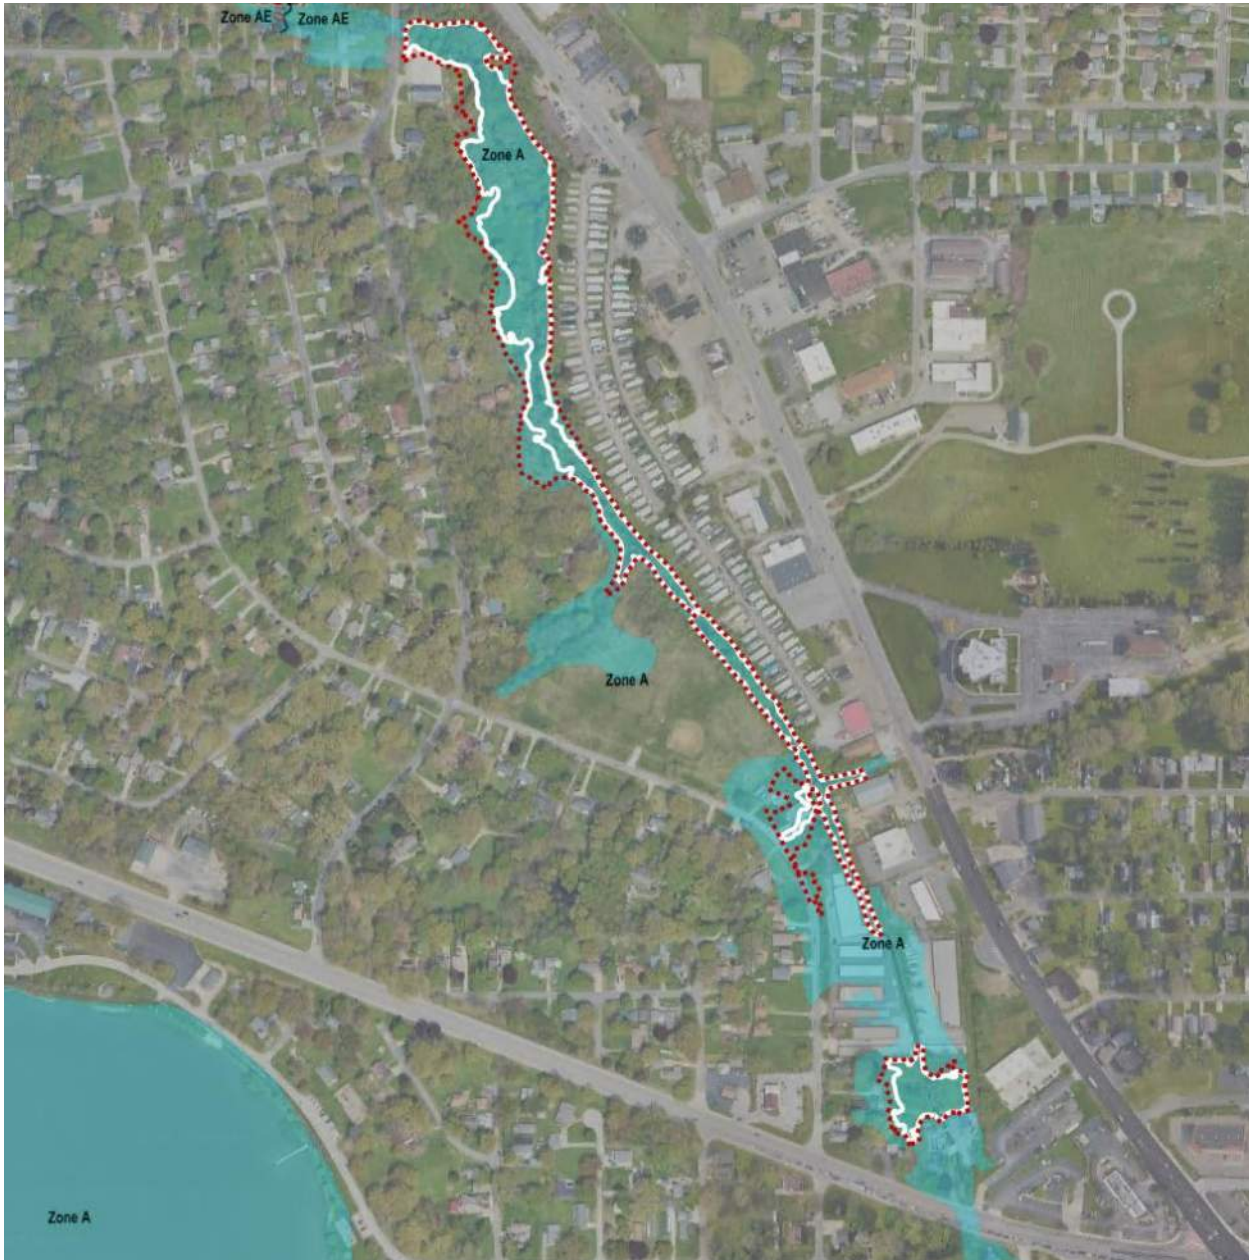
Flood map of the lake outlet channel illustrating the impact of tributary flow detention. The red dashed line represents the flood extents as predicted by the proposed condition HEC-RAS model, and the white solid line represents the flood extents as predicted by the same HEC-RAS model but with the reduced tributary flows. The filled area denotes FEMA Zone A.

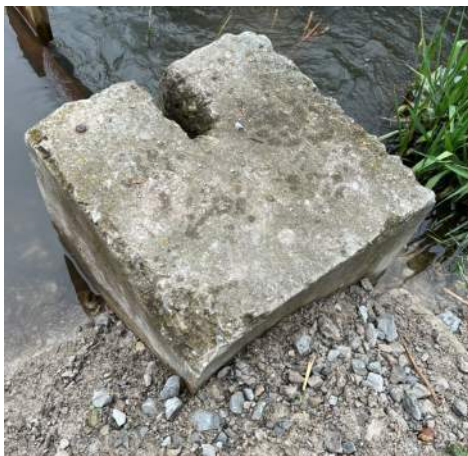
East Abutment

DLZ's Sunit Jain, Senior Structural Engineer, along with Akhil Konuru, Structural Engineer I, visited the Outfall Structure on 4/10/24 and visually inspected its condition from the east bank of the Channel. The concrete abutment on the east bank of the Channel was tapped with a hammer. The sound produced indicated that the concrete of this abutment was in fair condition. The water was flowing a few inches over the weir at the time of this visit. The condition of the weir was not readily evident due to water flowing over it; however, its functioning appeared to be as intended. The west abutment was only visually inspected from the east bank and appeared to be in similar condition as the abutment on the east bank. See a few selected photos below:
