FEASIBILITY STUDY

PID 115383

SUM-CR8-9.08 (High Level Bridge)
N Main Street over Cuyahoga River

May 3, 2024

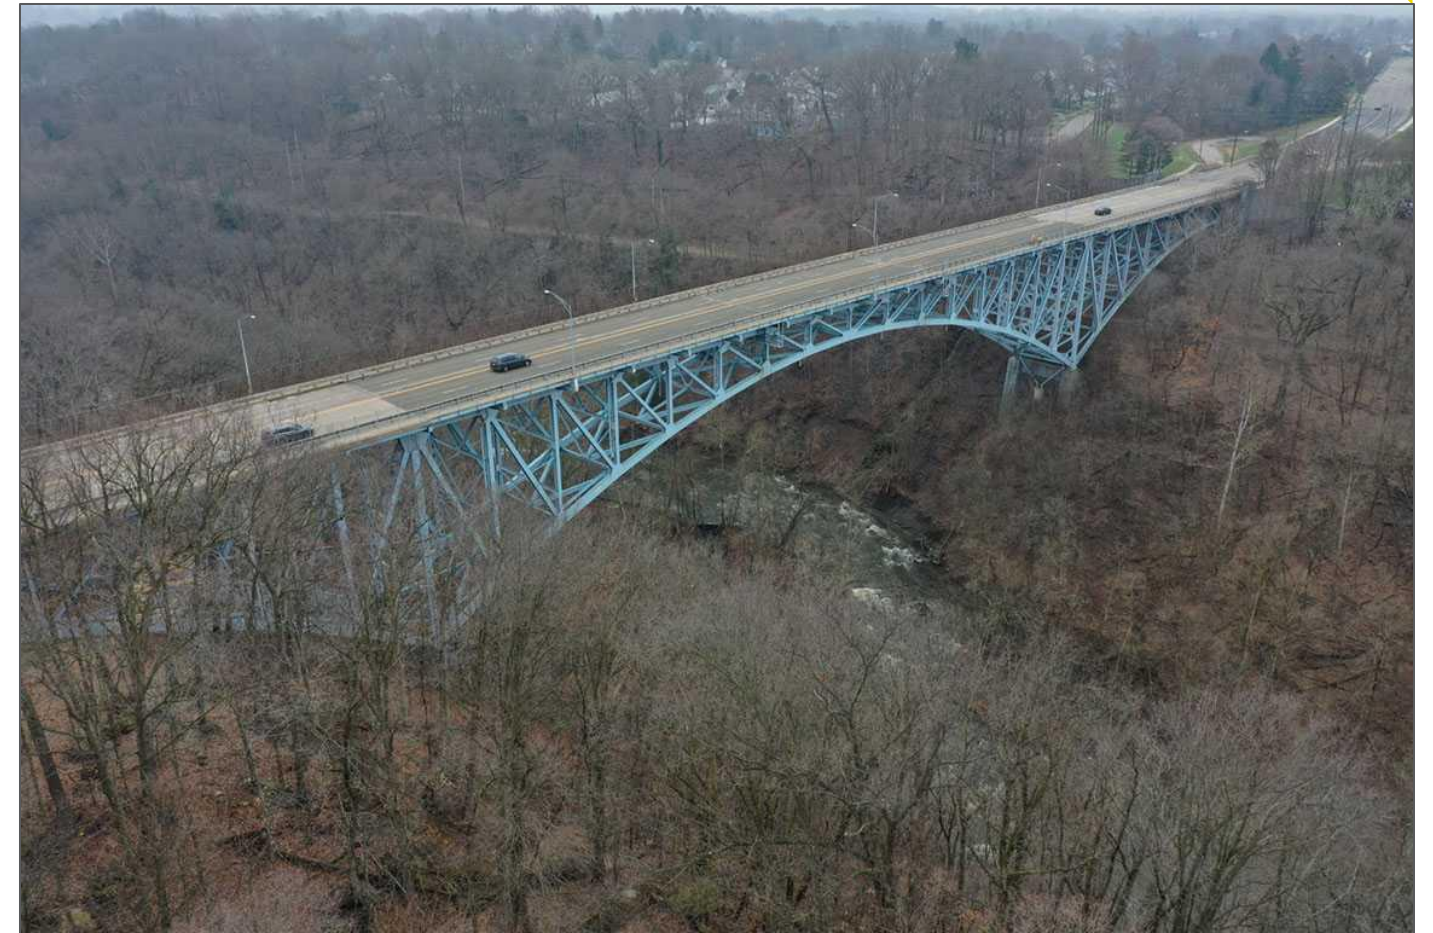
Photo 1: Existing Bridge Elevation Looking Southeast.

The currently existing bridge is a three-span steel cantilever deck truss with reinforced concrete deck carrying two lanes and a sidewalk in each direction. The reinforced concrete abutments and piers are founded on spread footings. Span lengths are 210'-0"±, 480'-0"±, and 210'-0"± center-to-center of bearings. The end spans act as anchor spans with massive steel eye bar anchorage units embedded in the concrete abutment footings at each end. The middle span is 480'-0"± long consisting of a 120'-0"± suspended span between two 180'-0"± cantilevers. The bridge is on a tangent alignment with no skew. It was designed for S-20-40 Loading.

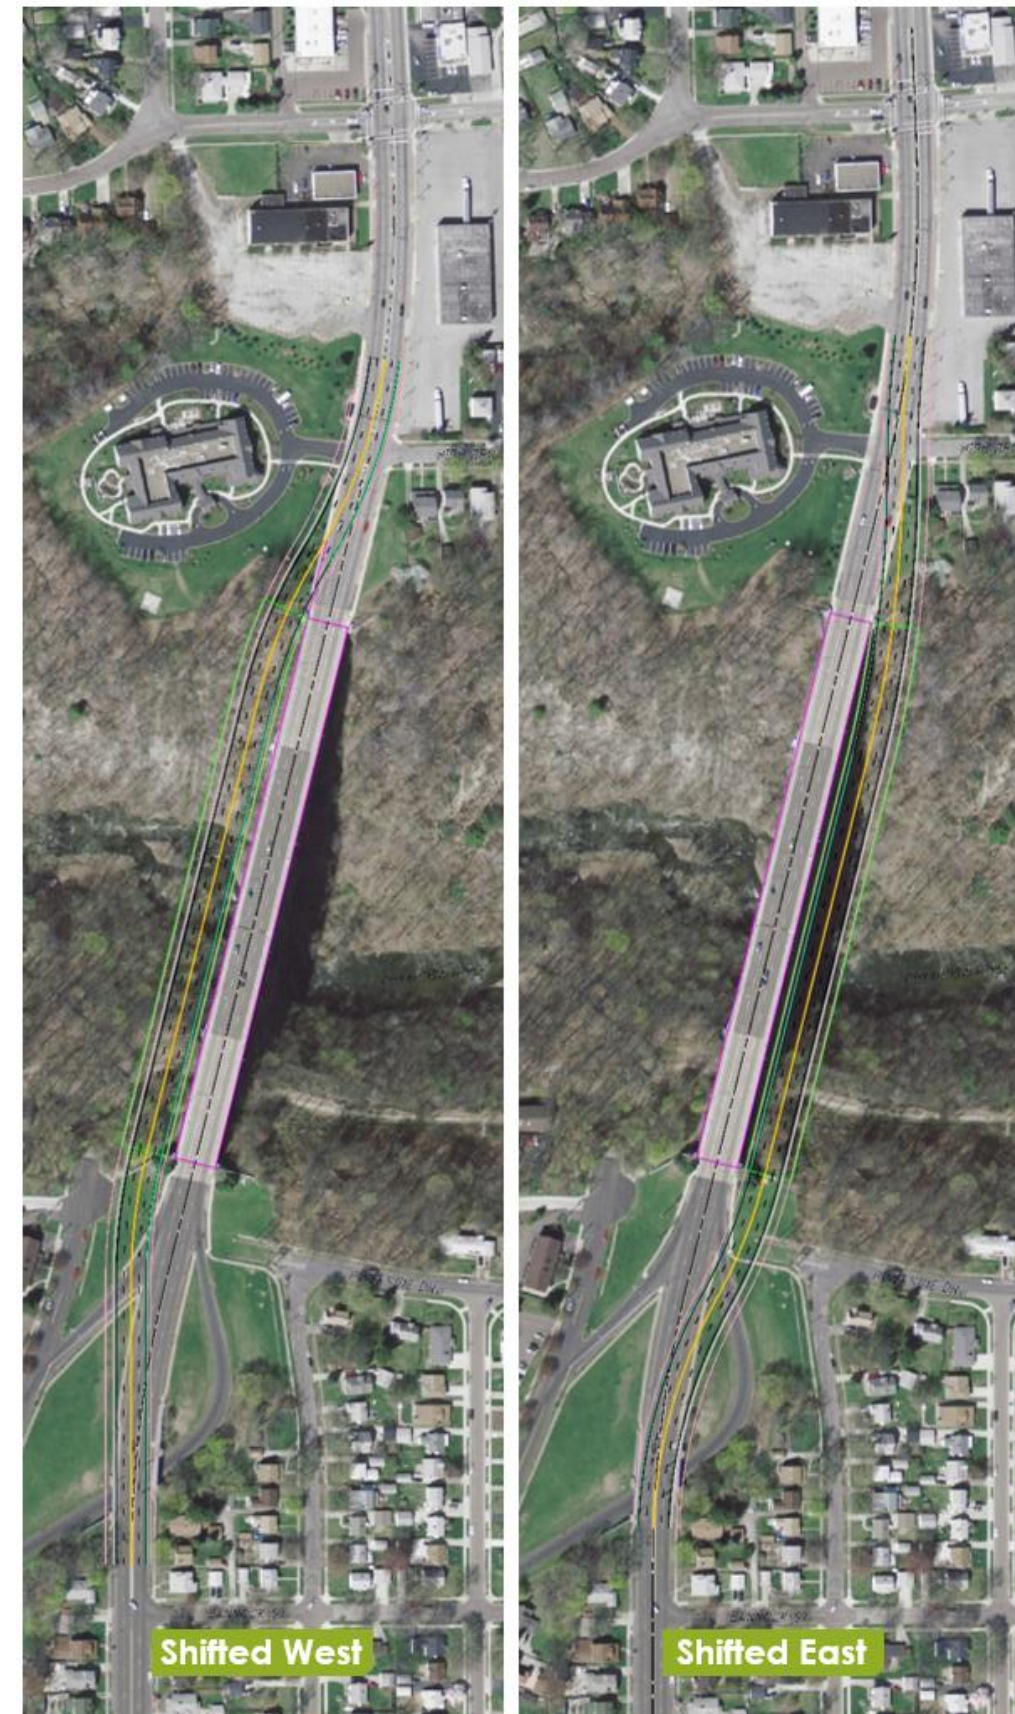
Figure 3: Proposed Preliminary Alignments Shifted to the West and to the East.

The recommended course of action emerged with the proposal to relocate the bridge to the west, closer to its original position when Howard Street served as the connecting road. This option offers minimal disruption to surrounding properties, with ample right-of-way available on the south side of the bridge and limited impacts to lawns and driveways on the north side. Notably, the relocation is strategically offset to optimize cost-effectiveness in bridge construction, precluding the feasibility of phased construction overlapping with the existing structure's footprint while avoiding the original bridge foundation locations. Consequently, the decision was made to construct the new bridge in its entirety before shifting traffic and subsequently demolishing the old bridge.

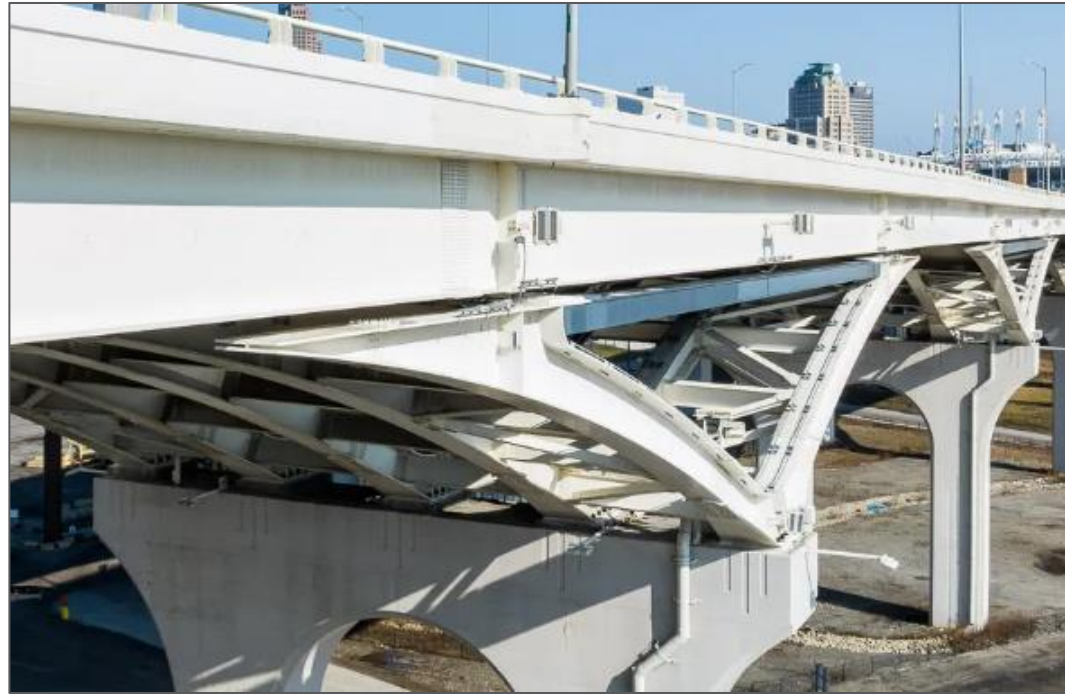
Figure 5: I-90 Innerbelt Bridge, Eastbound Girder Configuration

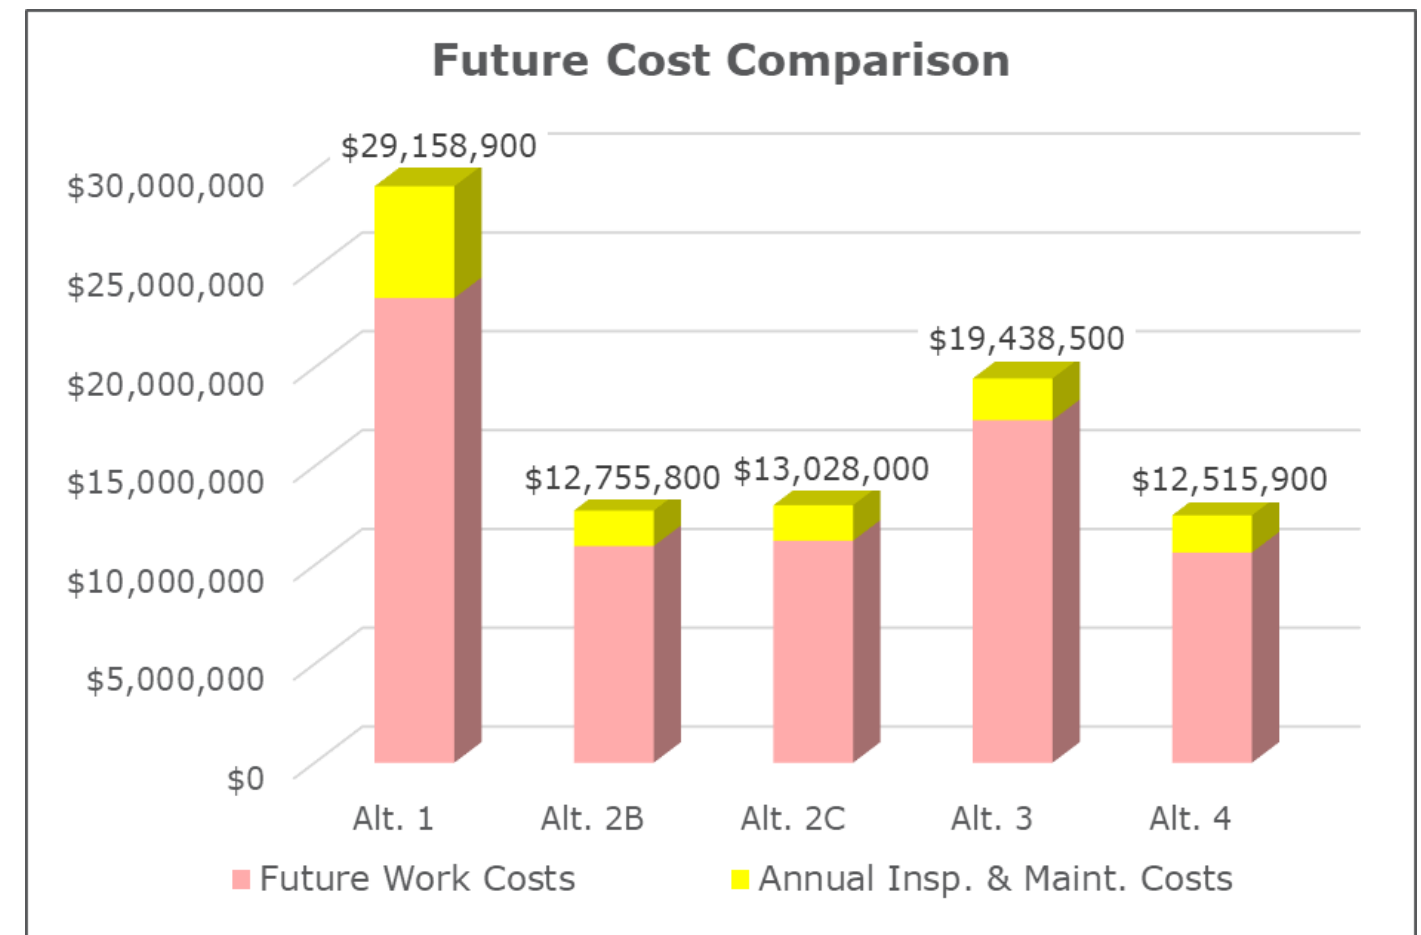
Figure 9: Future Cost Comparison

Future Cost Comparison				
Alternative	Description	Future Work Costs	Annual Insp. & Maint. Costs	Total Future Costs
1	Rehabilitate Existing Bridge	\$23,506,100	\$5,652,800	\$29,158,900
2B	Three-Span Welded Steel Plate Girder Bridge	\$10,961,200	\$1,794,600	\$12,755,800
2C	Four-Span Welded Steel Plate Girder Bridge	\$11,233,400	\$1,794,600	\$13,028,000
3	Open Spandrel Redundant Steel Plate Girder Arch Bridge	\$17,328,000	\$2,110,500	\$19,438,500
4	Post Tensioned Segmental Concrete Box Girder Bridge	\$10,633,400	\$1,882,500	\$12,515,900
