FINAL REPORT OF SPRINGFIELD LAKE NO. 1 OUTLET STRUCTURE & CHANNEL STUDY

Task B – Preliminary Plan

Springfield Township, Summit County

March 11, 2025

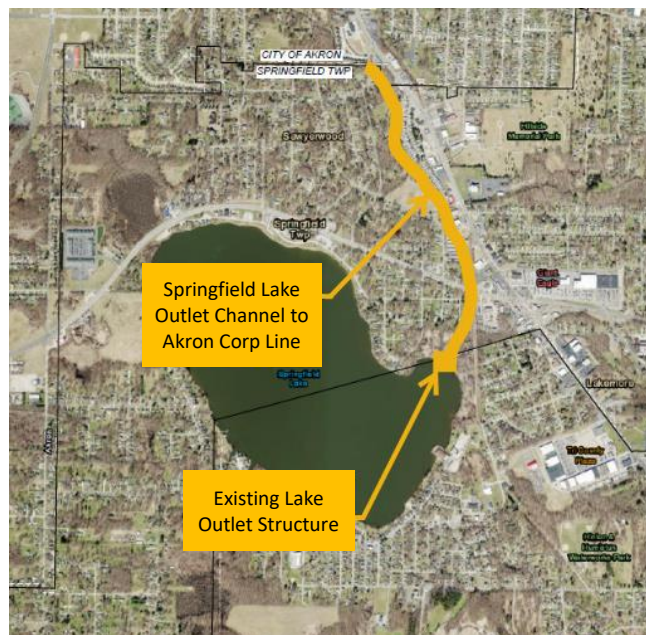
Figure 1: Springfield Lake General Project Area

Summit County (the County) plans to perform improvements at the Springfield Lake (the Lake) outlet structure and channel. Springfield Lake is located in Springfield Township, just South of The City of Akron border, see **Figure 1** below. The existing lake outlet structure and channel flows North to the City of Akron limits, through commercial and residential areas. In the past, Summit County has had to dredge the channel which outlets Springfield Lake to clear debris and allow continuous flow. The County intends to perform these improvements to reduce the need for future maintenance and dredging. The proposed channel improvements will be designed to provide adequate capacity, reduce bank erosion, remove encroachments, and provide maintenance access and easements, as required.

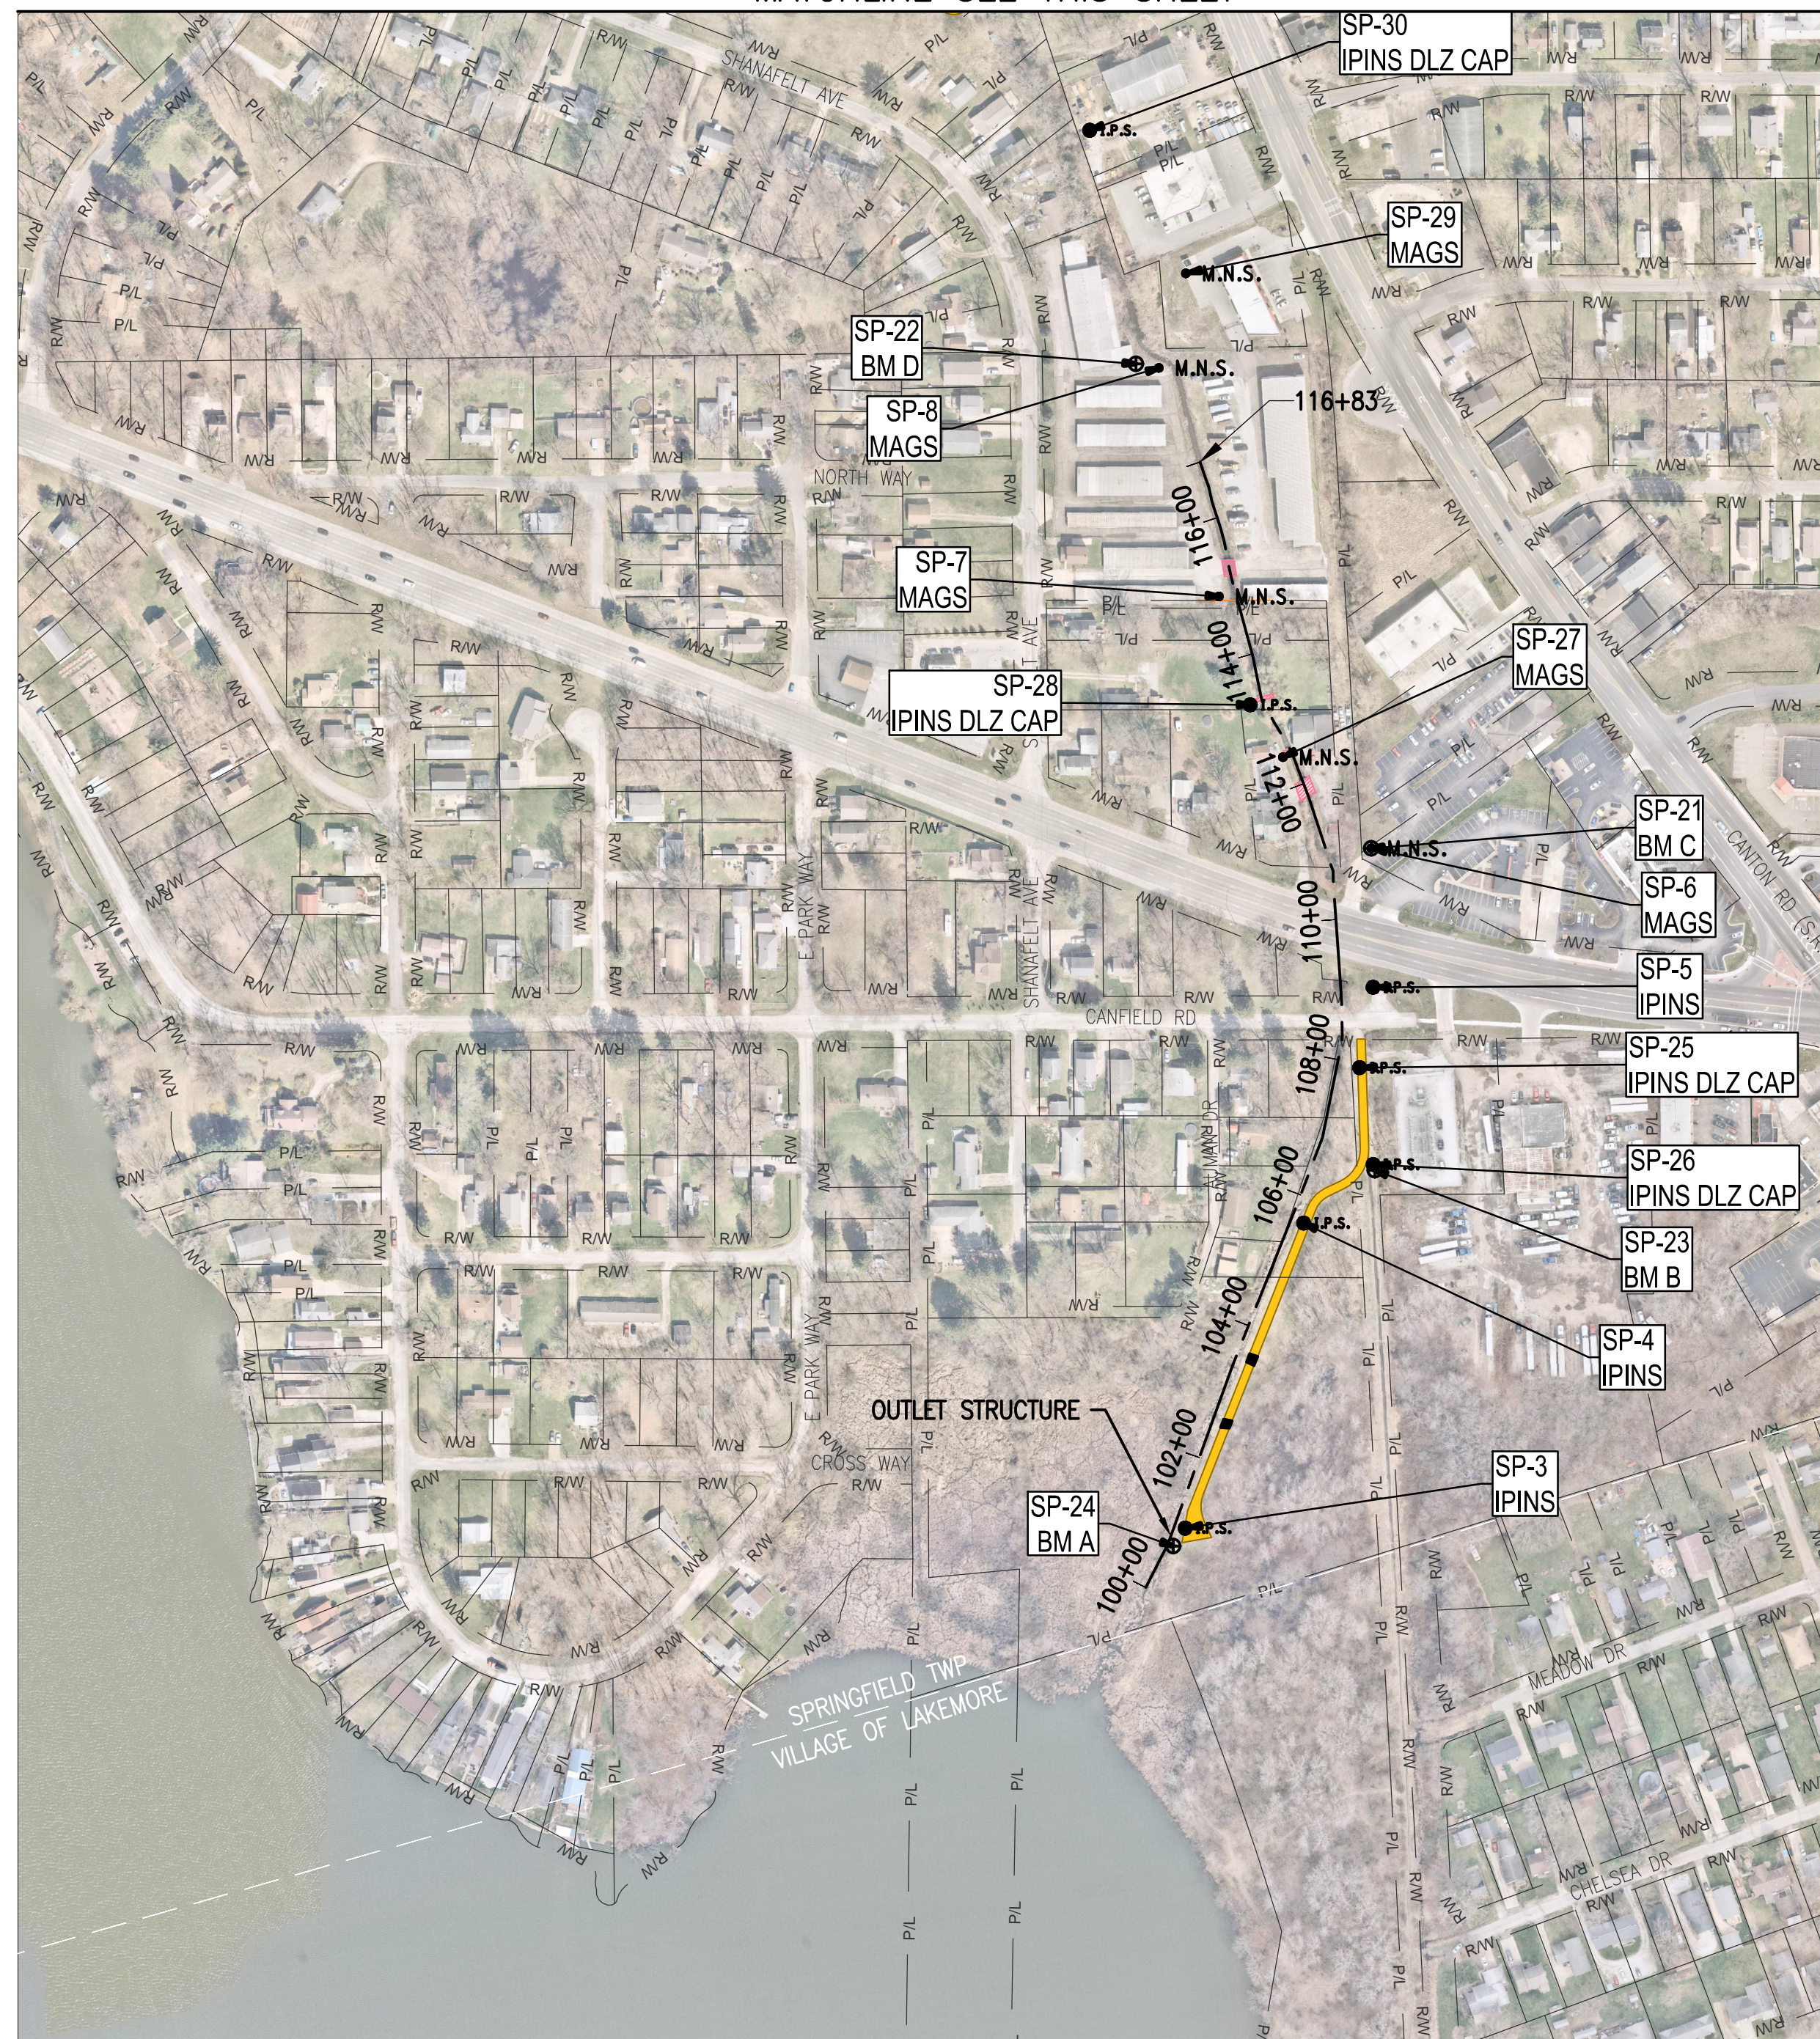
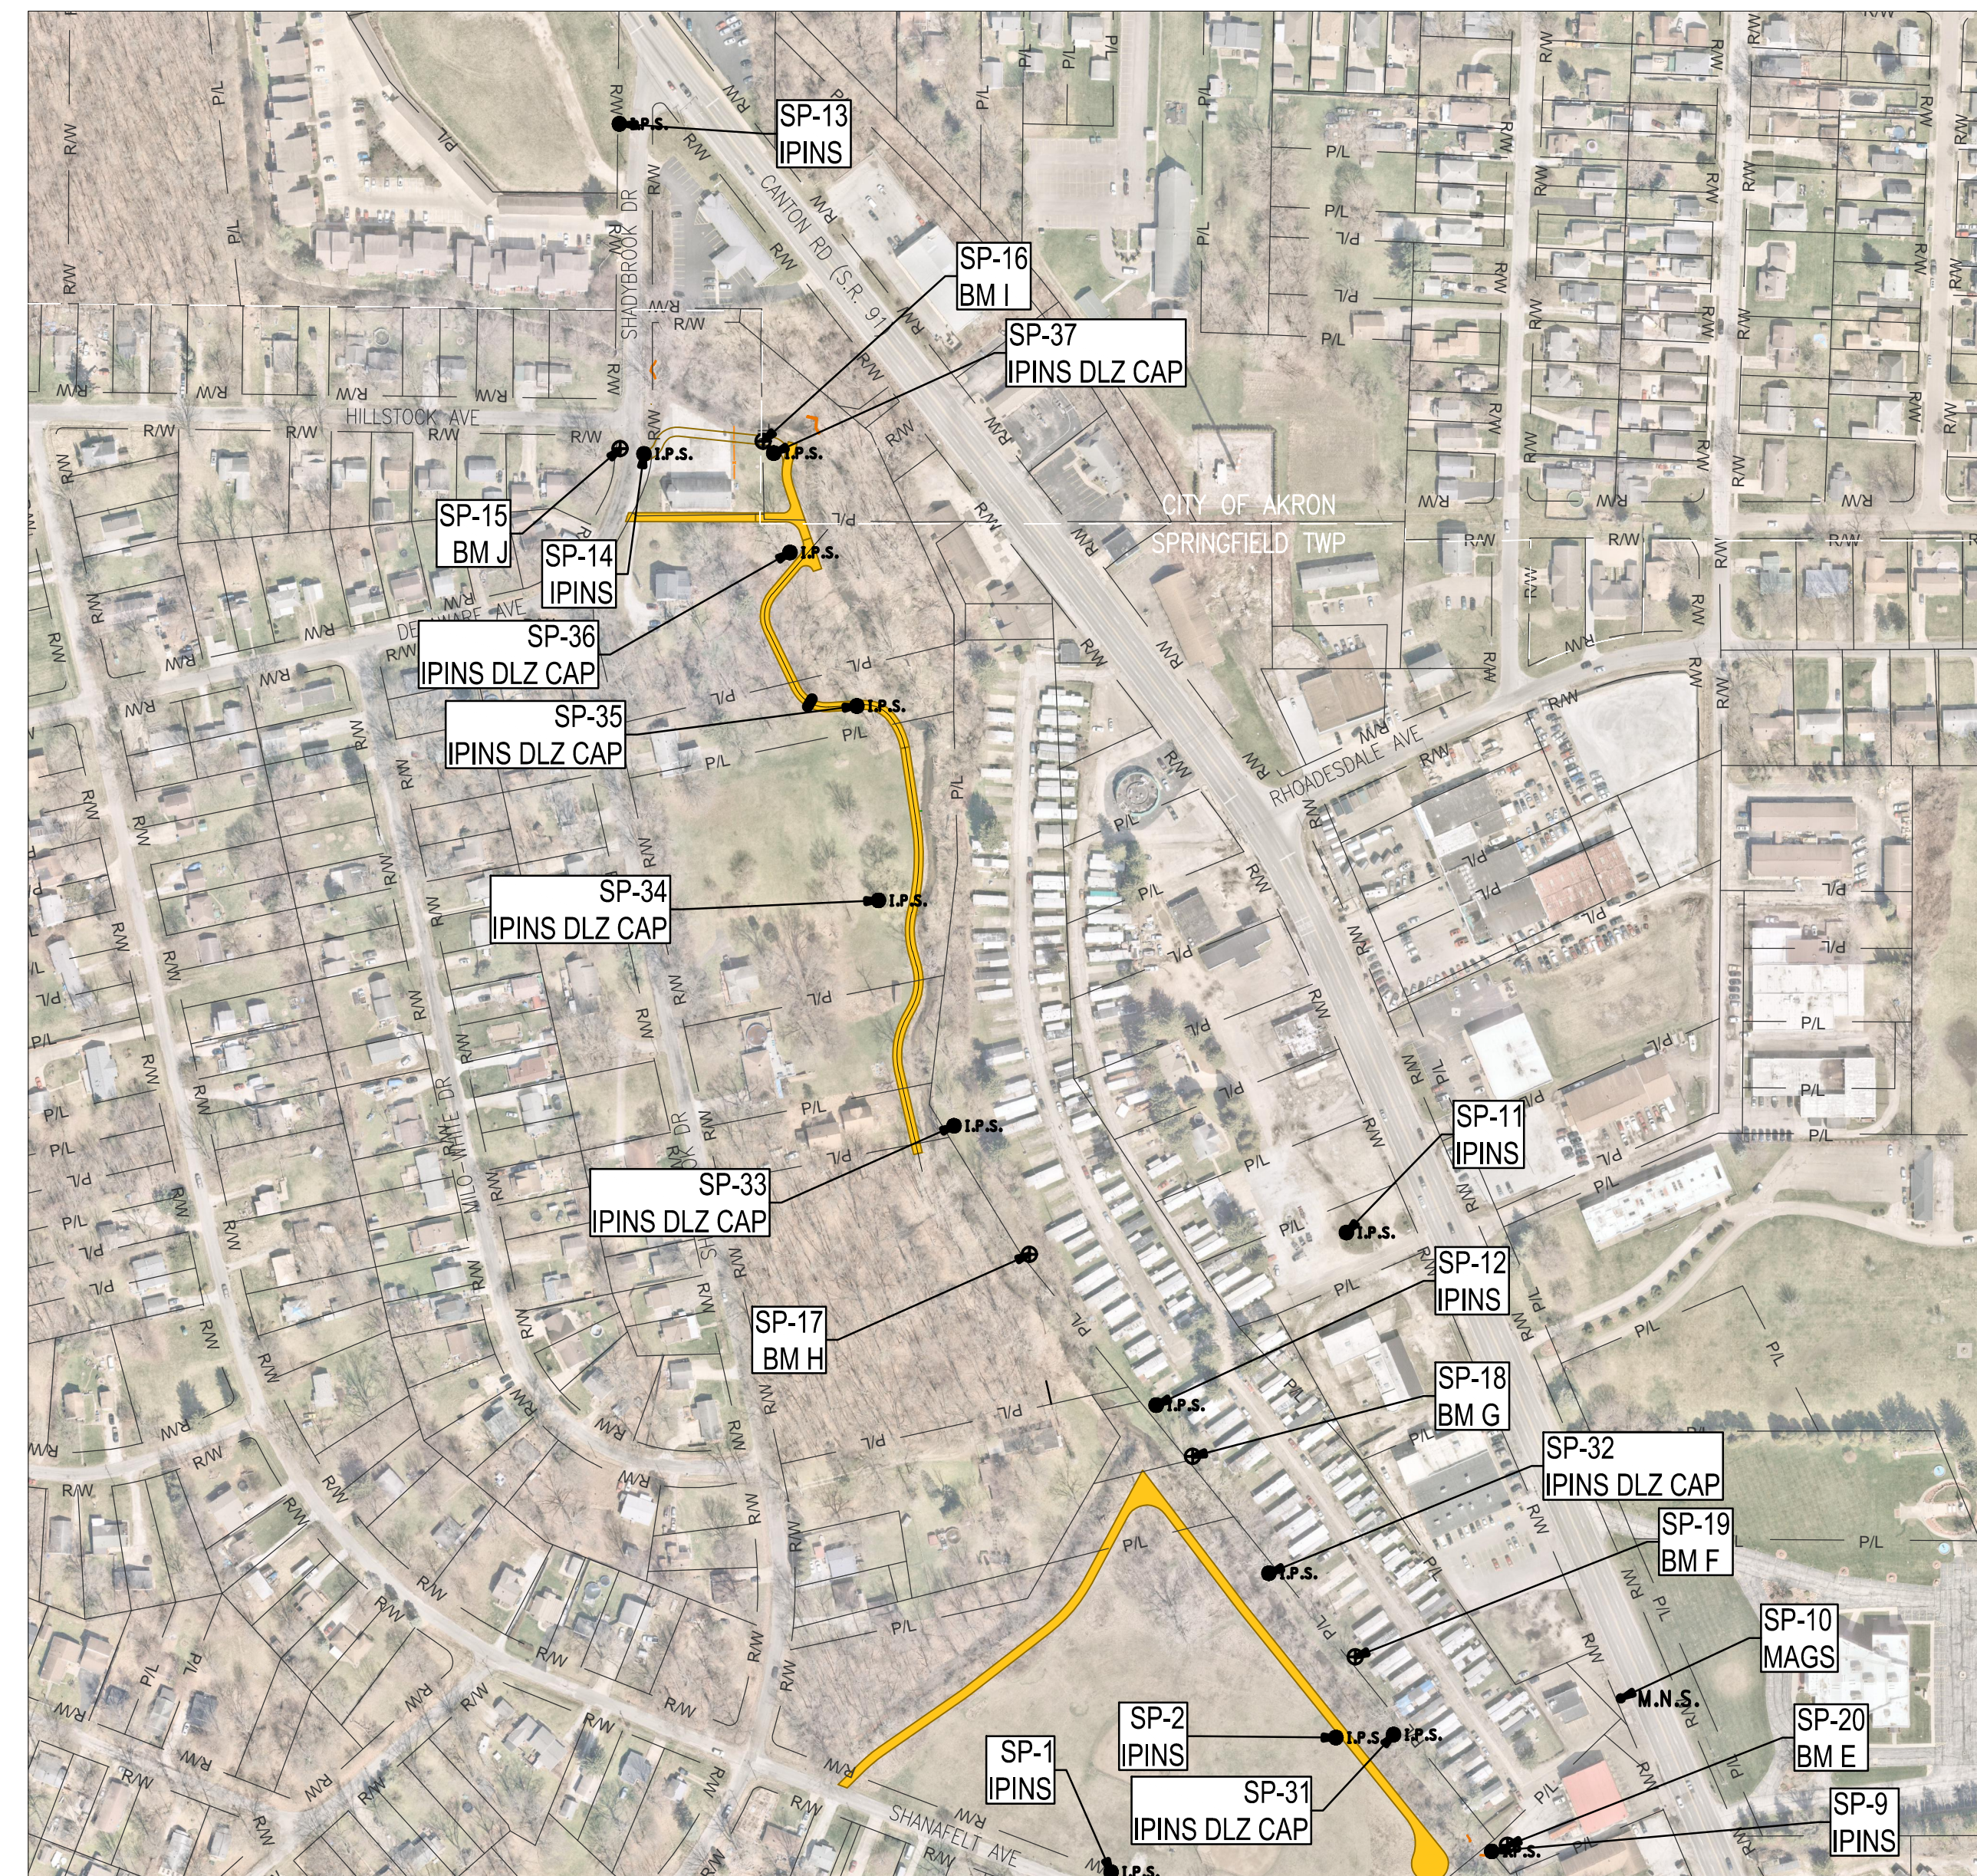
SURVEY CONTROL POINTS				
POINT	NORTHING	EASTING	ELEVATION	DESCRIPTION
SP-1	500,441.53	2,262,611.88	1075.66	IPINS
SP-2	500,624.24	2,262,917.22	1075.84	IPINS
SP-3	498,277.98	2,263,373.89	1075.68	IPINS
SP-4	498,711.40	2,263,542.24	1075.26	IPINS
SP-5	499,046.37	2,263,640.77	1078.67	IPINS
SP-6	499,243.88	2,263,638.23	1082.77	MAGS
SP-7	499,601.68	2,263,421.84	1077.29	MAGS
SP-8	499,926.27	2,263,336.54	1075.52	MAGS
SP-9	500,469.71	2,263,128.89	1075.85	IPINS
SP-10	500,677.52	2,263,304.09	1079.74	MAGS
SP-11	501,310.18	2,262,931.61	1077.79	IPINS
SP-12	501,075.72	2,262,673.11	1078.43	IPINS
SP-13	502,815.92	2,261,944.18	1089.93	IPINS
SP-14	502,367.68	2,261,977.46	1073.45	IPINS
SP-15	502,374.82	2,261,945.22	1073.24	BM J
SP-16	502,384.78	2,262,139.61	1072.12	BM I
SP-17	501,280.53	2,262,501.11	1072.50	BM H
SP-18	501,006.05	2,262,722.89	1076.04	BM G
SP-19	500,733.75	2,262,943.66	1075.44	BM F
SP-20	500,477.74	2,263,150.26	1076.47	BM E

SURVEY CONTROL POINTS				
POINT	NORTHING	EASTING	ELEVATION	DESCRIPTION
SP-21	499,243.83	2,263,638.21	1082.77	BM C
SP-22	499,931.88	2,263,304.01	1076.58	BM D
SP-23	498,786.38	2,263,643.28	1078.34	BM B
SP-24	498,252.43	2,263,357.21	1076.06	BM A
SP-25	498,932.22	2,263,621.59	1077.32	IPINS DLZ CAP
SP-26	498,794.73	2,263,640.87	1077.29	IPINS DLZ CAP
SP-27	499,373.35	2,263,512.74	1077.88	MAGS
SP-28	499,447.63	2,263,466.39	1074.78	IPINS DLZ CAP
SP-29	500,060.60	2,263,374.90	1077.31	MAGS
SP-30	500,263.85	2,263,238.42	1077.25	IPINS DLZ CAP
SP-31	500,628.27	2,262,995.48	1072.49	IPINS DLZ CAP
SP-32	500,847.48	2,262,826.17	1072.45	IPINS DLZ CAP
SP-33	501,455.20	2,262,398.63	1071.50	IPINS DLZ CAP
SP-34	501,761.21	2,262,295.96	1071.42	IPINS DLZ CAP
SP-35	502,025.30	2,262,266.59	1071.05	IPINS DLZ CAP
SP-36	502,233.86	2,262,175.78	1071.49	IPINS DLZ CAP
SP-37	502,368.74	2,262,153.83	1071.96	IPINS DLZ CAP
