OFFICIAL DETOUR
NOT TO SCALE

1. THIS DETOUR SHALL BE USED WHEN COMPLETE CLOSURE OF VANDERHOOF RD. IS REQUIRED DUE TO THE REPLACEMENT OF STRUCTURE FRA-C0215-0290 OVER TUSCARAWAS RIVER, AS DIRECTED BY THE ENGINEER.
2. ALL DETOUR SIGNING IS INCLUDED IN THE LUMP SUM ITEM 614 - DETOUR SIGNING.
3. DETOUR SIGNS SHALL BE COVERED WHEN NOT IN USE.

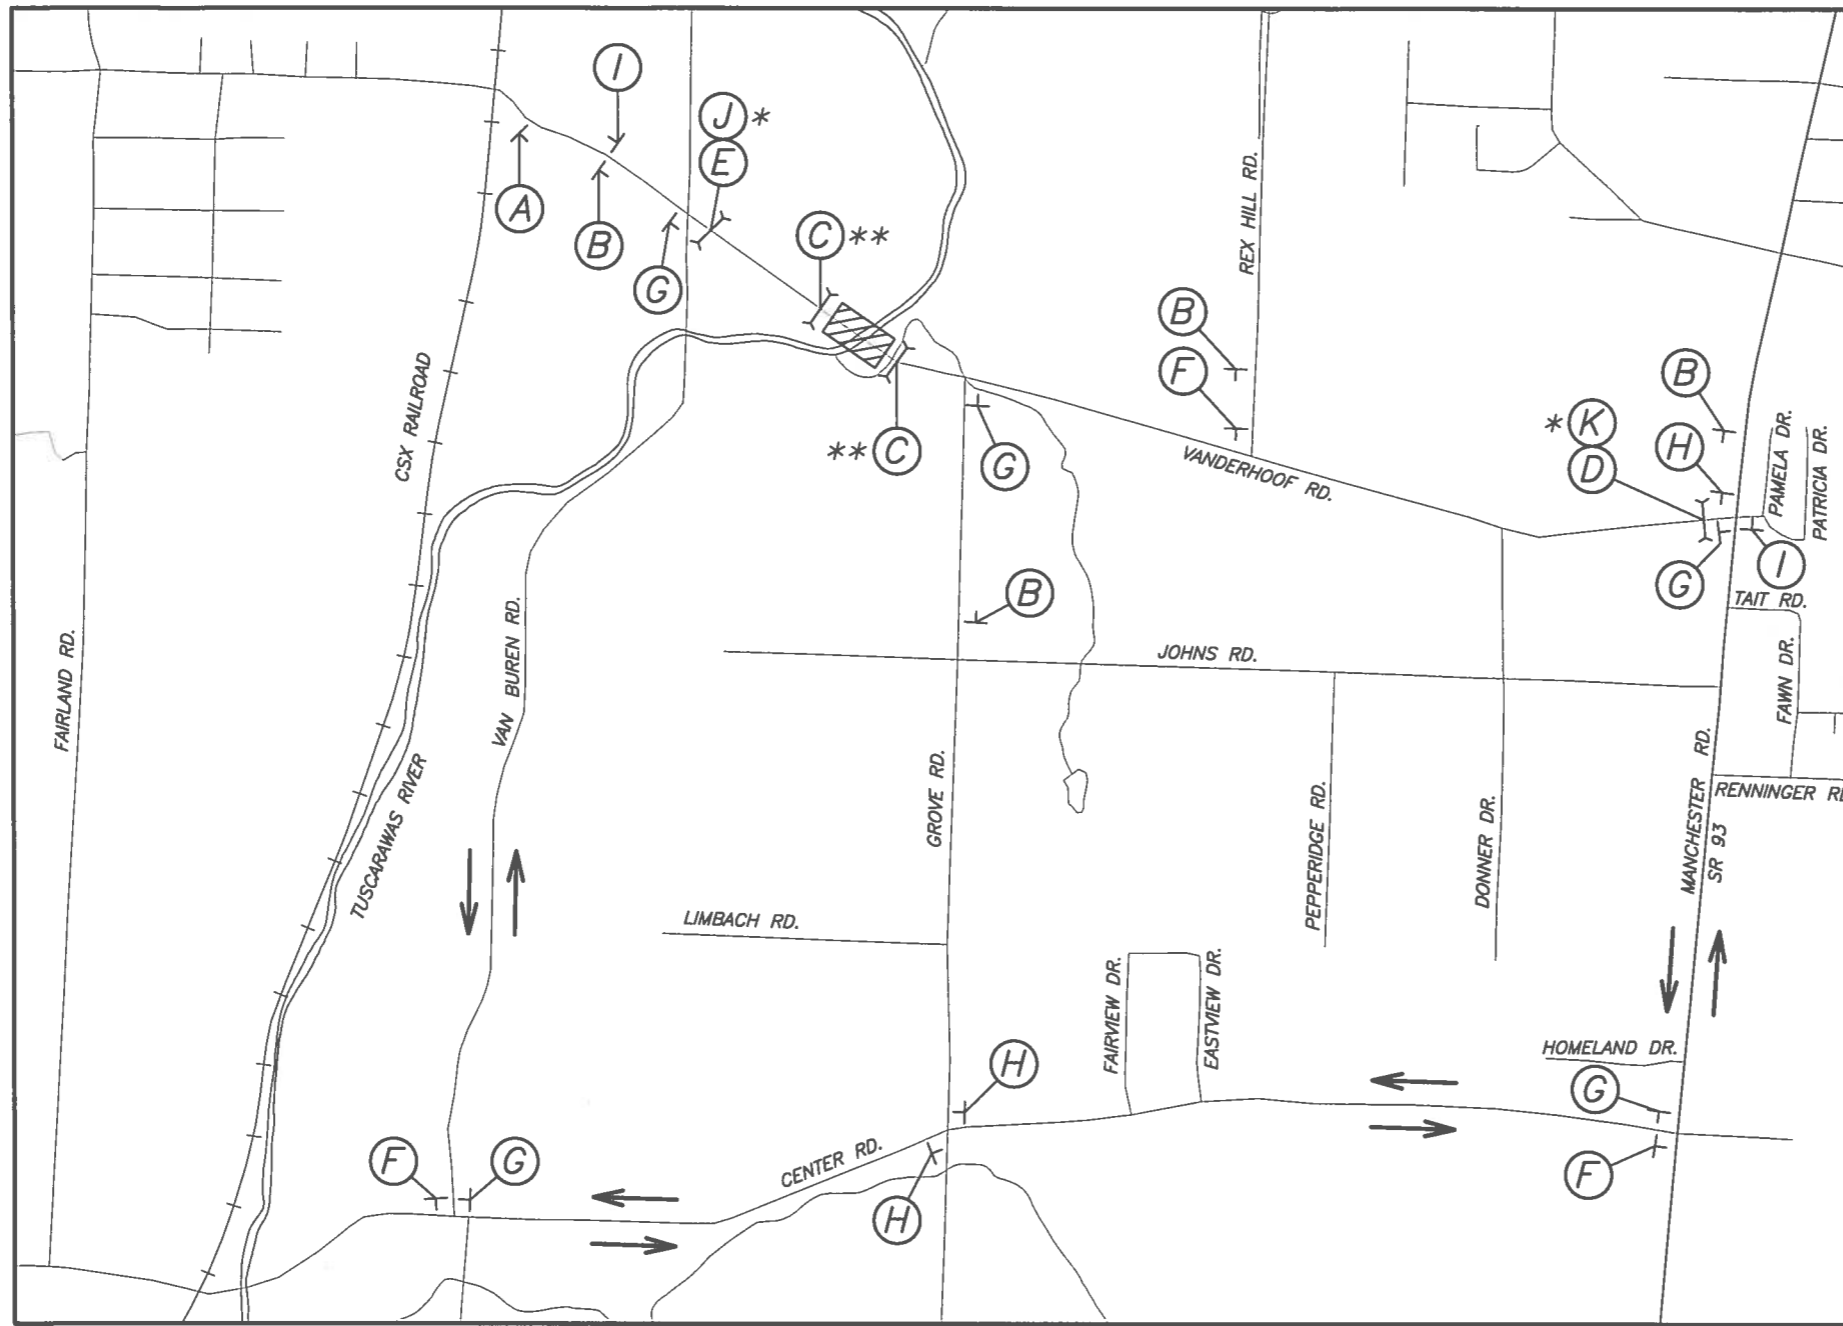
<p>(A) ROAD CLOSED AHEAD W20-3-36</p> <p>(B) Vanderhoof Rd D3-1 DETOUR AHEAD W20-2-36</p> <p>(C) ROAD CLOSED R11-2-48</p> <p>(D) DETOUR M4-10L-48</p> <p>(E) DETOUR M4-10R-48</p>	<p>(F) Vanderhoof Rd D3-1 DETOUR M4-9L-30</p> <p>(G) Vanderhoof Rd D3-1 DETOUR M4-9R-30</p> <p>(H) Vanderhoof Rd D3-1 DETOUR M4-H9T-30</p> <p>(I) Vanderhoof Rd D3-1 END DETOUR M4-8a-24</p> <p>(J) ROAD CLOSED 0.4 MILES AHEAD LOCAL TRAFFIC ONLY R11-3A-60</p> <p>(K) ROAD CLOSED 1.6 MILES AHEAD LOCAL TRAFFIC ONLY R11-3A-60</p>
--	--
